Phillips 66  
Bayway Refinery  
P.O. Box 222  
1400 Park Avenue  
Linden, New Jersey 07036

**NJPDES Permits NJ0001511**  
**NJPID #46318 & NJ0026671**  
**NJPID #46322 Report Response**

**Bayway Refinery**  
**February 24, 2020 Compliance Evaluation Inspection (CEI) Report**  
**NJPDES Permit Nos. NJ0001511 (PID #46318) & NJ0026671 (PID #46322)**

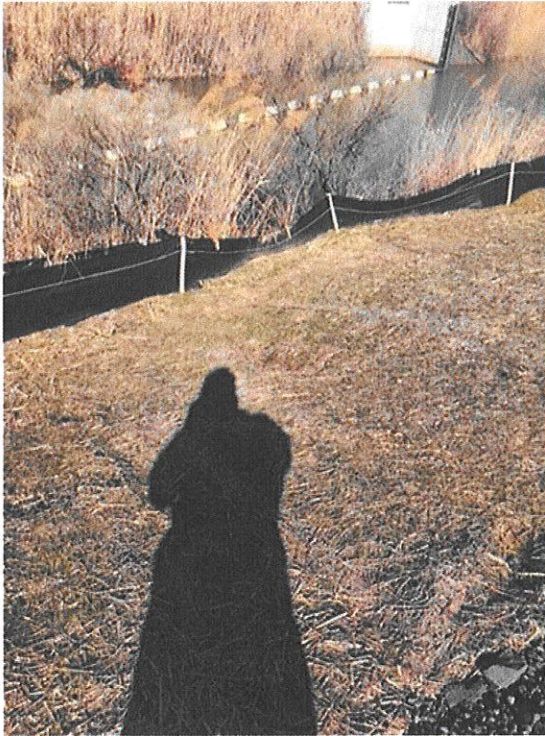
IMG\_3757 – Taken March 3, 2020

"Although the exact locations of images DSCN6754 and 6755 cannot be discerned from the photographs, it is believed they are in the proximal location of attached photograph IMG\_3757 taken on March 6, 2020. At the time when DSCN6754 and 6755 were taken, the area was still undergoing construction activities associated with SRP approved remedies. Subsequent to the photograph taken in June 2019, final grading was performed, erosion control matting installed and the area seeded. See photographs below for comparison.
